# Flightfax

ARMY AVIATION  
RISK-MANAGEMENT  
INFORMATION

AUGUST 2002 ♦ VOL 30 ♦ NO 8

## Spotlight: *AH-64 Safety Performance Review*

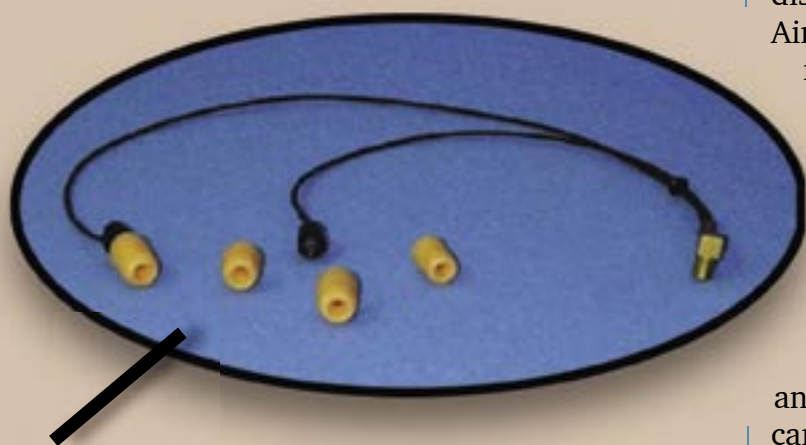
**T**he Communications Earplug (CEP) augments Army flight helmets by dramatically improving communication while simultaneously reducing noise exposure in rotary-wing aircraft. It consists of miniature transducers closely coupled with an expandable-foam earplug (Figure 1) that connects to the helmet communication system by an interface cable between earphone in the right earcup and the helmet shell (HGU-56/P and SPH-4B) or a connector attached to the communications cable (IHADSS).

Figure 1. The Communications Earplug and three sizes of Comply™ ear tips.

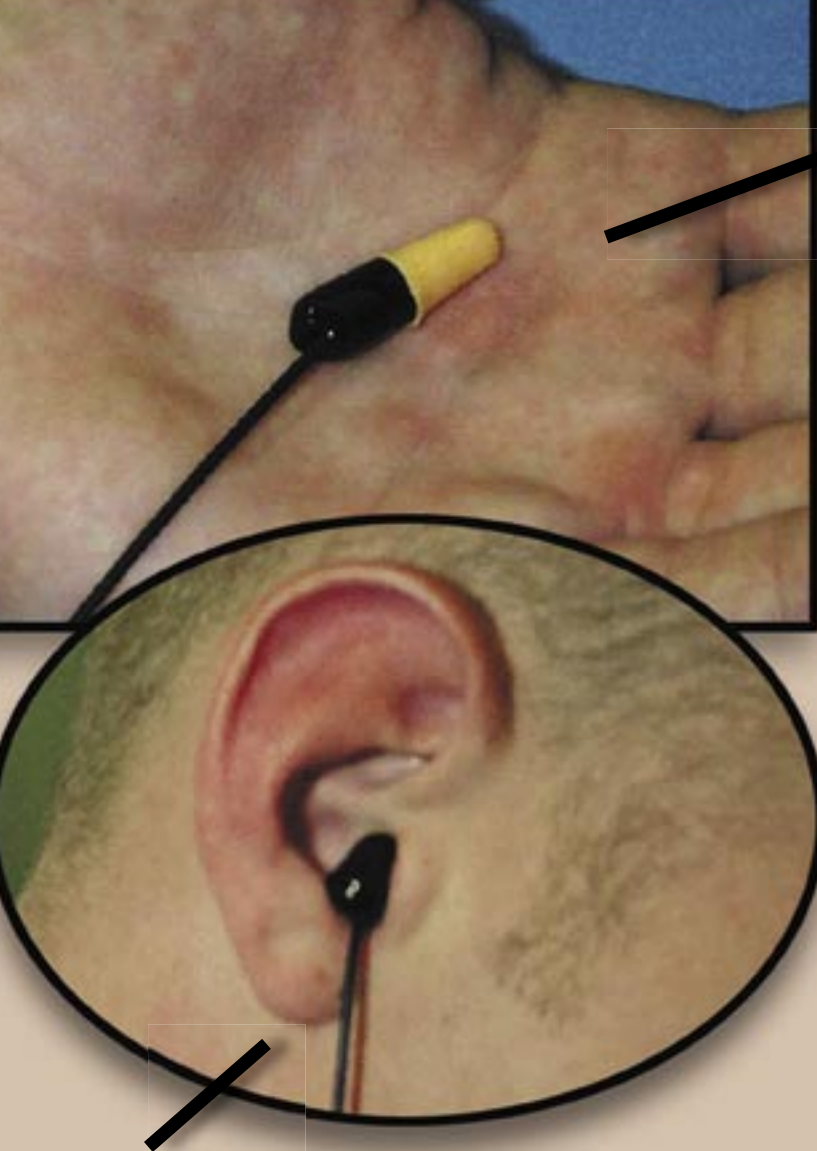
Figure 2. Comply™ Canal Tip correctly compressed prior to insertion into the ear canal.

Canal Tip for hearing protection. Rather than flattening the canal tip “like a key” (as is indicated in the packaging instructions) to obtain the proper hearing protection, the CEP canal tip should be *rolled* between the thumb and first two fingers into a small cylinder (see Figure 2). When inserting the rolled foam tip into the ear canal, it is best to use the opposite hand to pull the external ear up and away from the head, thereby straightening the ear canal and allowing for a clear path for the rolled canal tip.

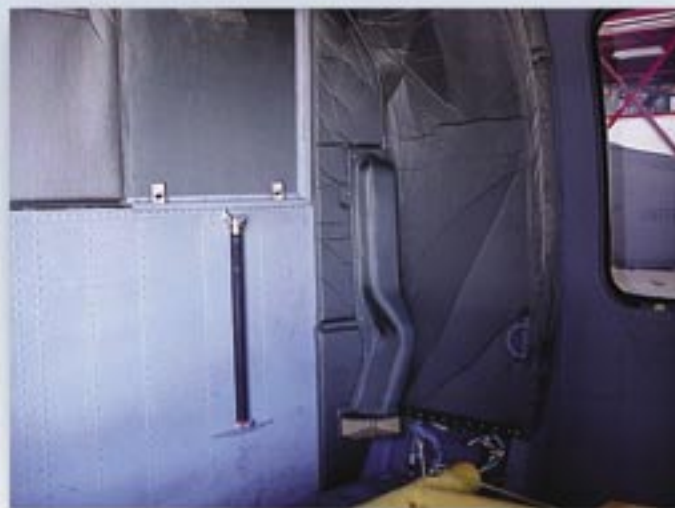
## WARNING

Crashworthiness of the aft outboard, forward-facing troop seats will be decreased if the auxiliary cabin heater duct installations at station 398 are present. The duct and diffuser installation near the floor protrudes beneath the troop seat allowing the seat to strike the diffuser and stroke envelope, potentially decreasing the energy attenuation provided by seat stroke action.
